PROVINCIAL GRAND LODGE OF WEST LANCASHIRE

Masonic Halls Part 2 – Practical Examples

Dr David Case, CEng, FIET
Vice Chairman – Leigh Group

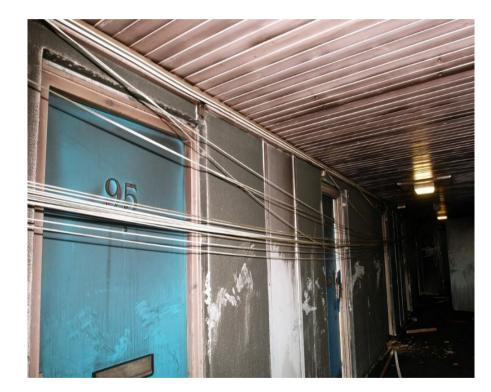
Shirley Towers – Southampton 2010. Twi firefighters killed due to cable entanglement.

- 8 Fire Fighter killed due to cable entanglement between Harrow Court fire (Hertfordshire 2005) and Shirley Towers fire (Southampton 2010).
- Cables now to be adequately supported by non-combustible fixings to prevent premature collapse throughout entire installation (18th Ed – BS7671) as well as protected escape routes (17th).
- FSO includes unlimited fines and prison. Typical fines £20k-£250k.

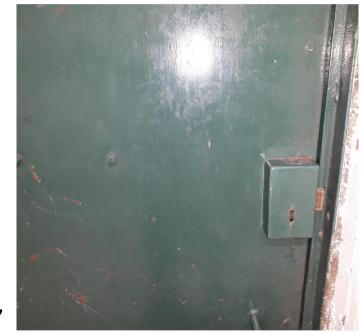
DOOR FROM BAR TO OUTSIDE

- Keyless operation needed to comply as a Fire Exit;
- Nearest alternative Fire Exit is over 20m + 3 doors;
- Stockroom Insurer wants high security and not just a Crash Bar. (Some Crash Bars are rated for High Security).

- The door (1980's) isn't certified to a modern standard;
- Insurance specify 45mm thick doors, but 'only' 6mm of metal so theoretically 'non-compliant';
- The lock is an obscure size and doesn't comply to BS6321, but it protected by 6mm metal without external access;
- The bolt is bent (due to door warping) and the lock is difficult to operate.

- Produce Door Design Justification Report to demonstrate to the Insurer that door is adequate even though not of an "approved type";
- Finesse the door to fit properly (Sledge Hammer and muscles required);
- Fit a Heavy Duty keyless exit mechanism (for compliance with fire regulations);
- Add a big handle to close door easily;
- Monitor lock bolt from Intruder Alarm.

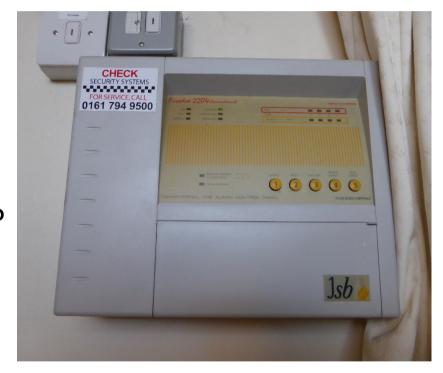
OLD SYSTEM

- Manual call points only;
- Reliant on a human to initiate alarm;
- No automatic smoke or heat detectors;
- What happens when building unoccupied?
- Equipment obsolete (not easy to add remote monitoring due to age).

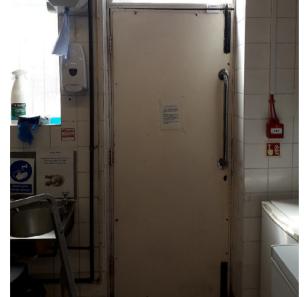
OLD WOODEN DOOR – INWARD OPENING, WITH LOCK AND KEY

- 1960's Door, over clad and painted;
- Opens inwards not compliant as a Fire Exit; key lock; bolts; poor hygiene; broken window above. Old & Worn.
- Attacked after Sportsman's dinner.
- Alarm 'Tampered' but still activated
- Intruders left immediately.

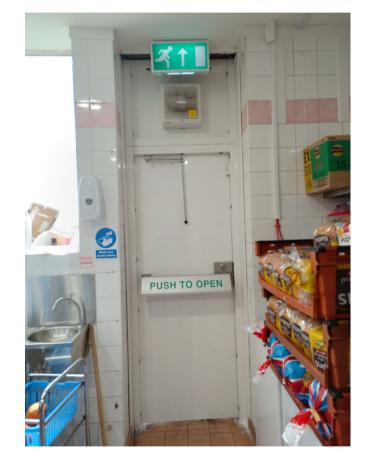
Improved Compliance with Security Assessment and Fire Assessment

- Install a Metal LPS1175 SR2 door;
- Outward opening with Crash Bar operation. Illuminated Exit Box;
- Better space usage;
- 'Impossible' to kick in;
- Has a total mass of about 130kg;
- Over panel with purge extractor;
- Has stay open option for ventilation;
- Kitchen staff, Insurers and Fire Officer all pleased with improvement.

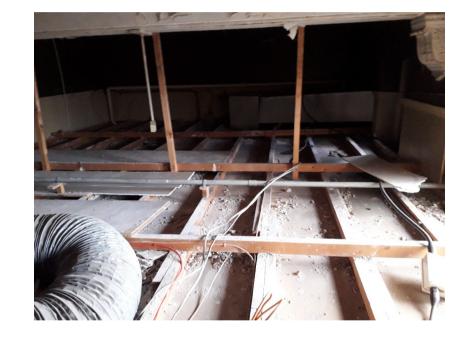
FALSE CEILING 20+ YEARS OLD.

- Unsafe 3"x2" structure could collapse when cleaning extract ductwork;
- Plaster board not fireproof;
- Lack of Fire Barrier above ceiling to adjacent corridor;
- Badly positioned Emergency Light;
- Extensive debris above ceiling;
- Use of ladders (on slippery Kitchen floor).

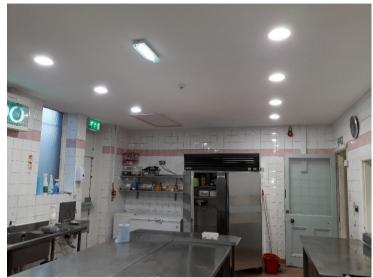
A more useable Kitchen – improved Fire compliance; Less Maintenance; Work at Height risk removed; No Risk of Collapse; improved energy efficiency.

- New 6" x 2" structure (all debris removed);
- Double Fireproof skimmed plasterboard;
- Installed loft ladder and crawl boards;
- New brighter LED Lighting (71% energy saving and easier to keep clean);
- Relocate Emergency Light better location;
- Rockwool fire barrier to corridor with fireproof plasterboard.

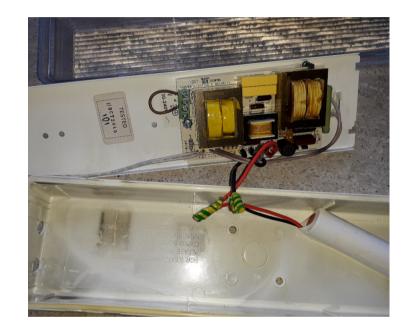
How did these Pass?

A simple visual inspection determined these were Not safe.

- Make a register of all portable apparatus;
- All items need some visual inspection;
- Low power devices, eg Computer leads and phone chargers could just be visually inspected (3A-5A);
- PAT test high power leads, eg 10A-13A:
 - Kettles & Toasters:
 - Extension leads;
 - Portable oil filled heaters;
- Keep records of dates of inspection, fuse size, condition etc;
- Quarantine (and dispose of) any un-safe equipment.

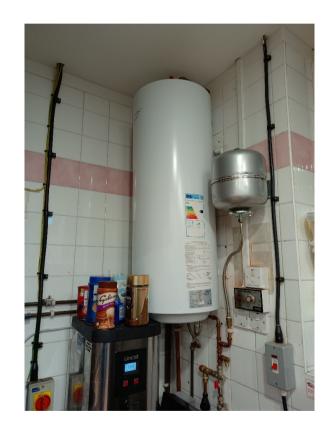
KITCHEN GAS POWERED HW SUPPLY

- Obsolete water heater new circuit board £600;
- On demand system with limited HW flow rate;
- Takes 3-5min to fill a sink.

- Electric storage heater (100 Litre stored capacity and smart control learns usage pattern);
- Fills sink in <60 seconds faster for kitchen staff;
- Decommission a Gas service in the kitchen;
- Save cost of yearly service visit, reduce building risk...
